Osmose_® P 0 L m PACIFIC INSPECTION GAS & ELECTRIC CO. & TREATMENT DETAIL REPORT

***		2/68	2/	POLE #:						
			and and	- 64 10161		CALCULATION SHEET	CALCIII				
Prepared by Classon, Tom 3/24/2014	NOTES:		Del Mar-Atlantic #2	Del Mar√	LINE NAME:	D GRADE A	WOOD

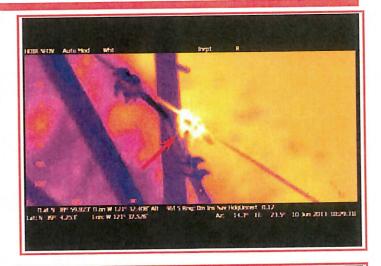
Severity of Problem: III (Intermediate)

_		z
	1 CA-70 E	
_	Found Hot Connectors Found Hot Connectors on Jumper From 723/211 to Toli A oli A oli A 29/211	رہا
	w 2 -	3
		0
	03.86	di
		1
	2 7 5 7 2	10
	atrol a Hot mper to 7 1211.	2
	R Path Sund June 1 29/211	Orlarmo- BOOWL
	x 10 2 11	0
	2 6 × × × × × × × × × × × × × × × × × ×	
		7
	enpod-omrolad & O.A. sund	
	ONDOG-OUISOLOS & CONTROL OF CONTR	
	× 21/0 - 2003 0/03	
	1500 O.A -12009	
	OS SERVICE SER	
	Ser	
	A -10252- 115 KV TABLE MOUNTAIN R. O.	
	The state of the s	
	So Color	
	MO BILL MAN	
	PALERMO-BOGUET -10252- 115 KV Switching Center: TABLE MOUNTAIN Switching Center: TABLE MOUNTAIN	
	200	
	\(\sum_{00000} \)	
	244264020	
	George Ave
